Monobuoy Reference Project for

... Ifrikia Overhaul Project

Ifrikia Hinge replacement

Clients:
SEREPT

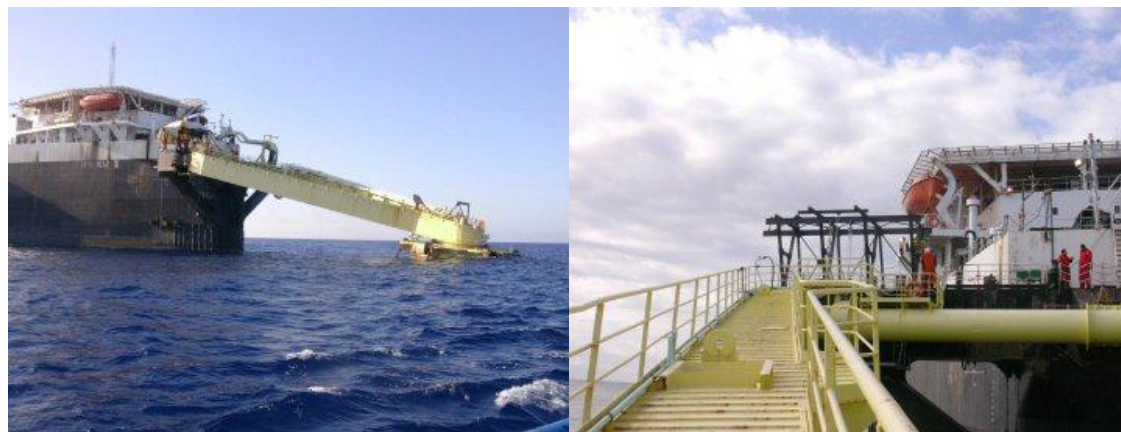
The starboard hinge has been reported to be giving problems for several years. It has always been noisy and been subject to vibrations when moving in either the rotational or axial directions. The noise was the worst when the axial hinge had excessive play which allowed the radial hinge to be moving excessively in an axial direction. There are a series of previous reports, which describe the problem, and the different stages of material coming out of the hinge, and bolts breaking etc which sufficiently document these problems.

It had been assumed that the problem was coming from excessive wear or damage to the Tufnol bush, and the recommended remedy had been to change this bush.

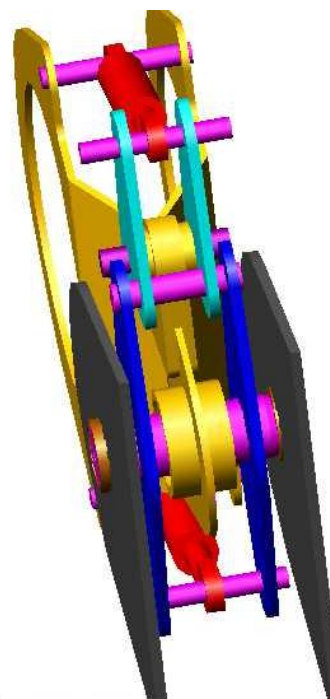
The shaft required a large force to free the shaft from the welded by rust. The total force required was in the region removing this shaft

two supports where it had been firmly of 380 to 400 tons. Nearly 2 days were spent

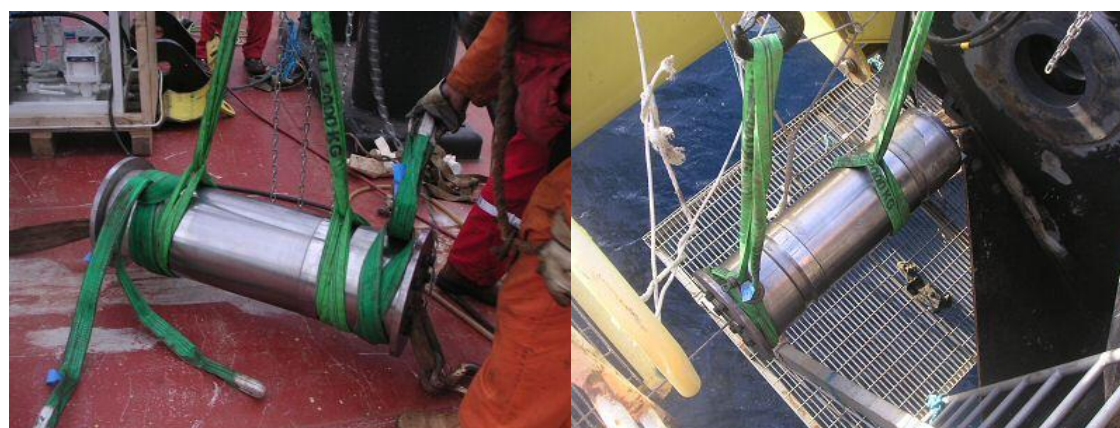
It was noted that the horizontal cylinder was moving in and out with the motion of the tanker pulling and pushing. This motion is an indication of the play caused by wears in the radial hinge.

It was noted that with a sea state of 1.5 to 2.0 m wave and 10-knot wind, the pressure was varying between 70 to 90 bars. The temporary hinge was inspected. Mechanically, there were no anomalies noted. There was a slight click heard when the hinge was moving axially.

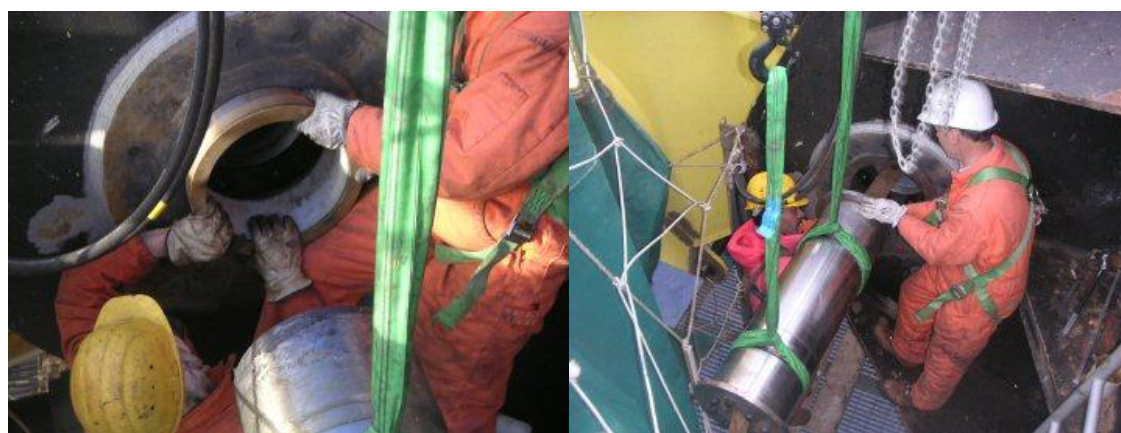
By measurement on the Merriman to shaft position, the yoke was lifted until the main shaft was centralized in the Merriman. The horizontal position was also verified. The wear on the tufnol bush was checked and found to be around 7 mm. (daily report 26.06.2005).

The test was found to be satisfactory both structurally and for the sea state encountered. The actual pressures required for adjustment of the position of the radial hinge being significantly lower than the working pressure of the hydraulic system meant that:
