Monobuoy Reference Project for

... Ifrikia Overhaul Project

Ifrikia Hinge replacement

Clients:
SEREPT

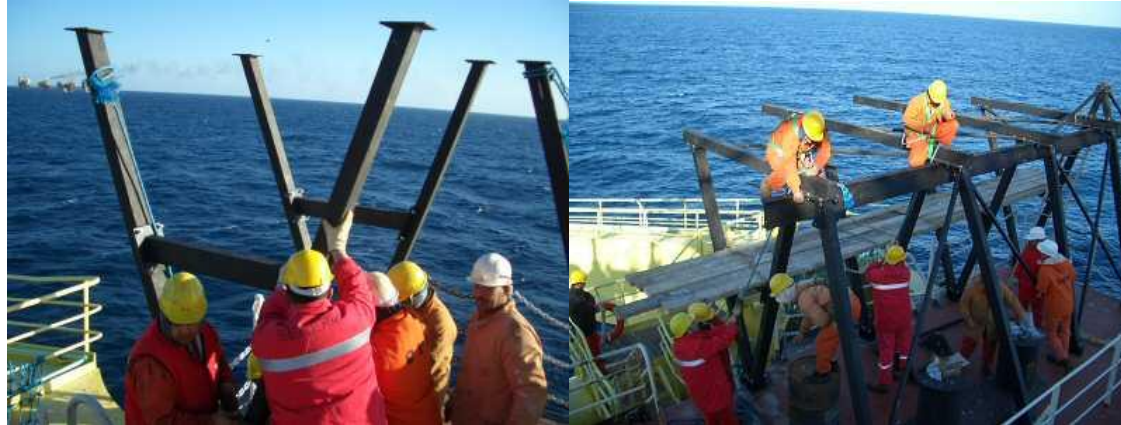
A monorail was installed above the axis of the main and auxiliary hinge starboard. This monorail extended over the side of the barge to allow items to be lifted directly from a supply boat below. The monorail assembly was a bolted unit and had a SWL of 2.5 Tonne.

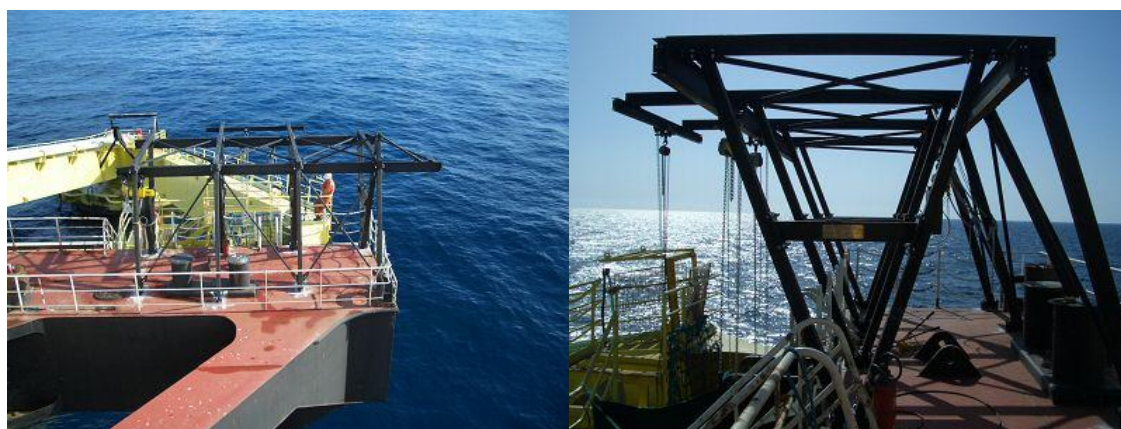
The monorail was designed in order to be used for the starboard hinge as well as for the onboard hinge if needed at a later stage. Prior to use, the monorail was tested in the presence of BV on 05.02.2005. The nameplate was stamped by BV to show the different load tests which were performed.

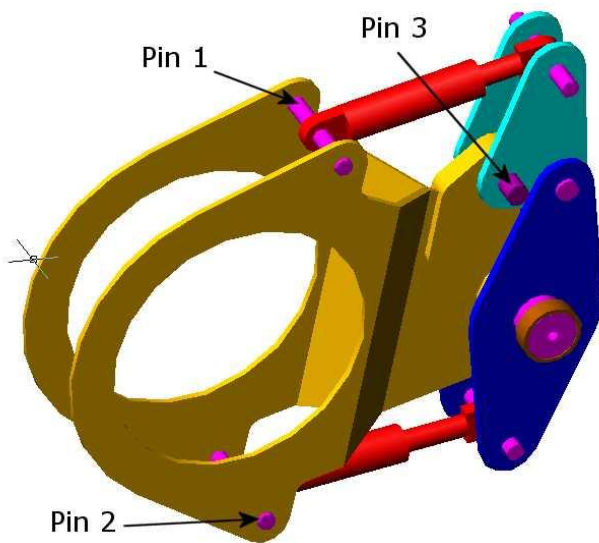
- 2 triangle links (shown in light blue)
- 2 diamond links (shown in dark blue)
- 1 special auxiliary shaft (shown in brown)
- 2 bronze bushes (shown in red), complete with hydraulic
- 2 hydraulic jacks (shown in yellow), complete with hydraulic
- 6 pivot pins (shown in purple)
- Hydraulic power pack (pneumatic supply)

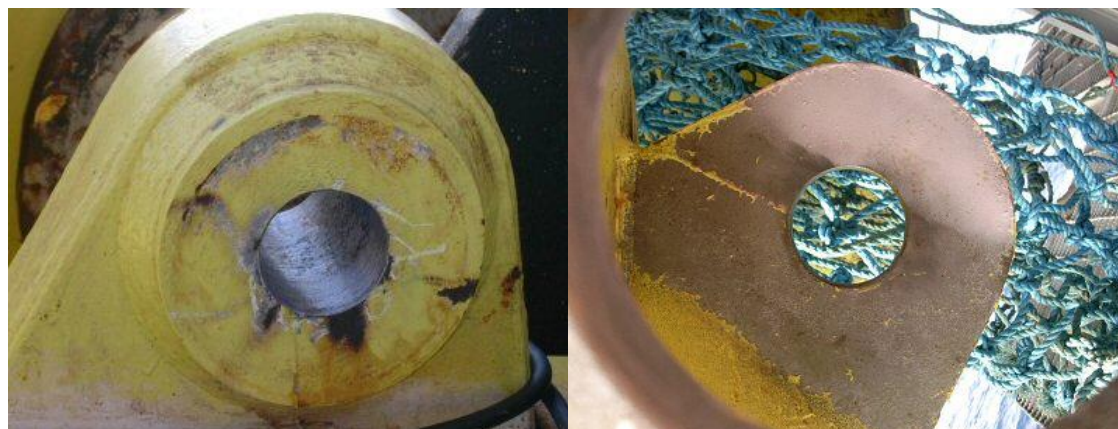
The bore of the yoke pivot bush was carefully cleaned and prepared by grinding such that the new shaft would be a tight fit.

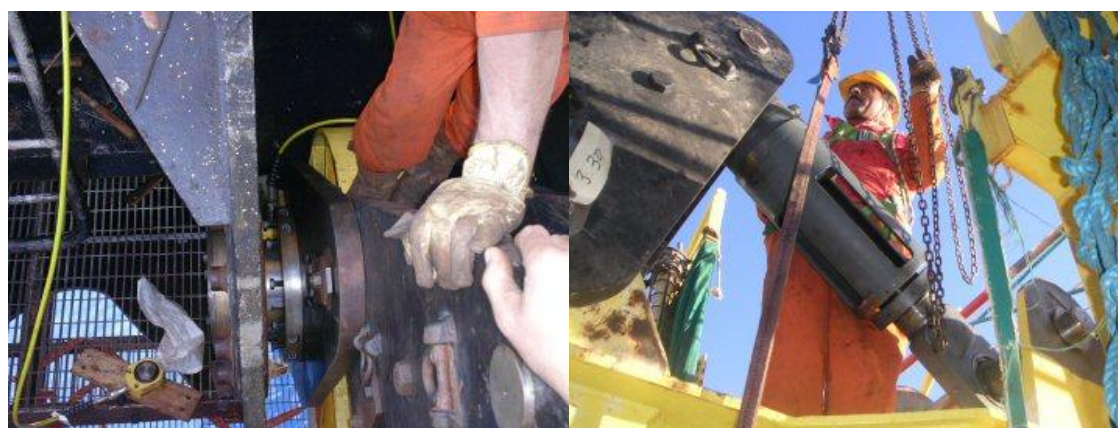
The machined shaft was installed into the yoke pivot lug and 2 triangle plates on the shaft.

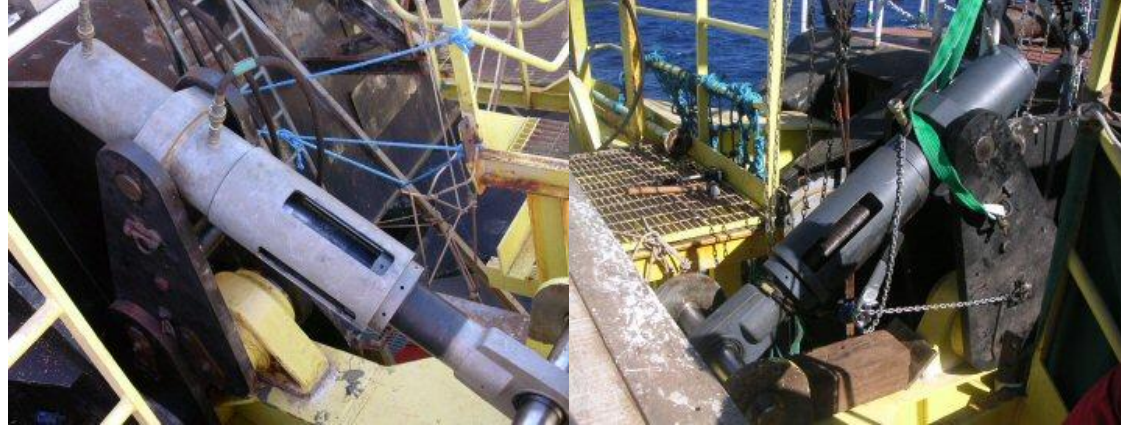
The upper cylinder was installed, only connecting the triangular plate end of the cylinder. The other end is left free to allow the triangular plate to rotate forwards sufficiently to be able to insert the connecting pin triangular plates / diamond plate.

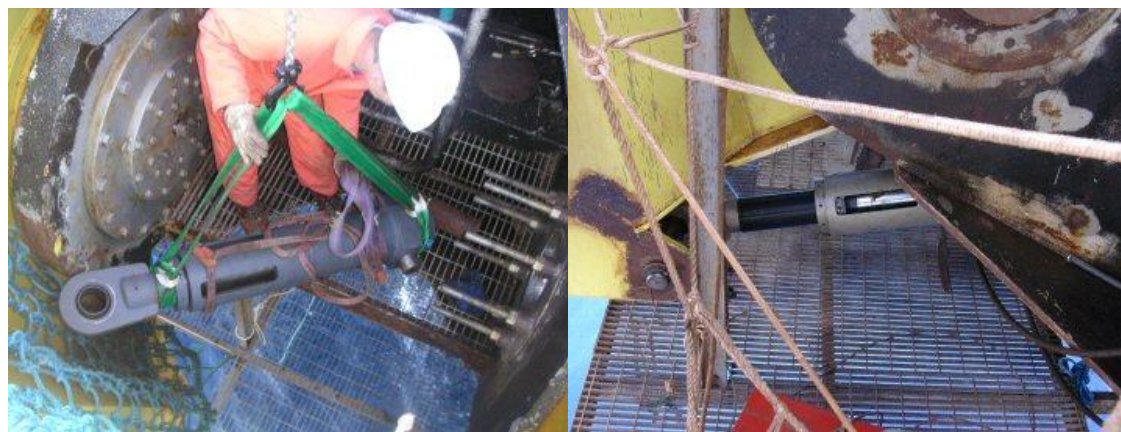
The lower cylinder was installed, only onto the lower side of the installed diamond plate. The free end of the cylinder was suspended with a sling from the underside of the yoke to allow for free movement of the cylinder.

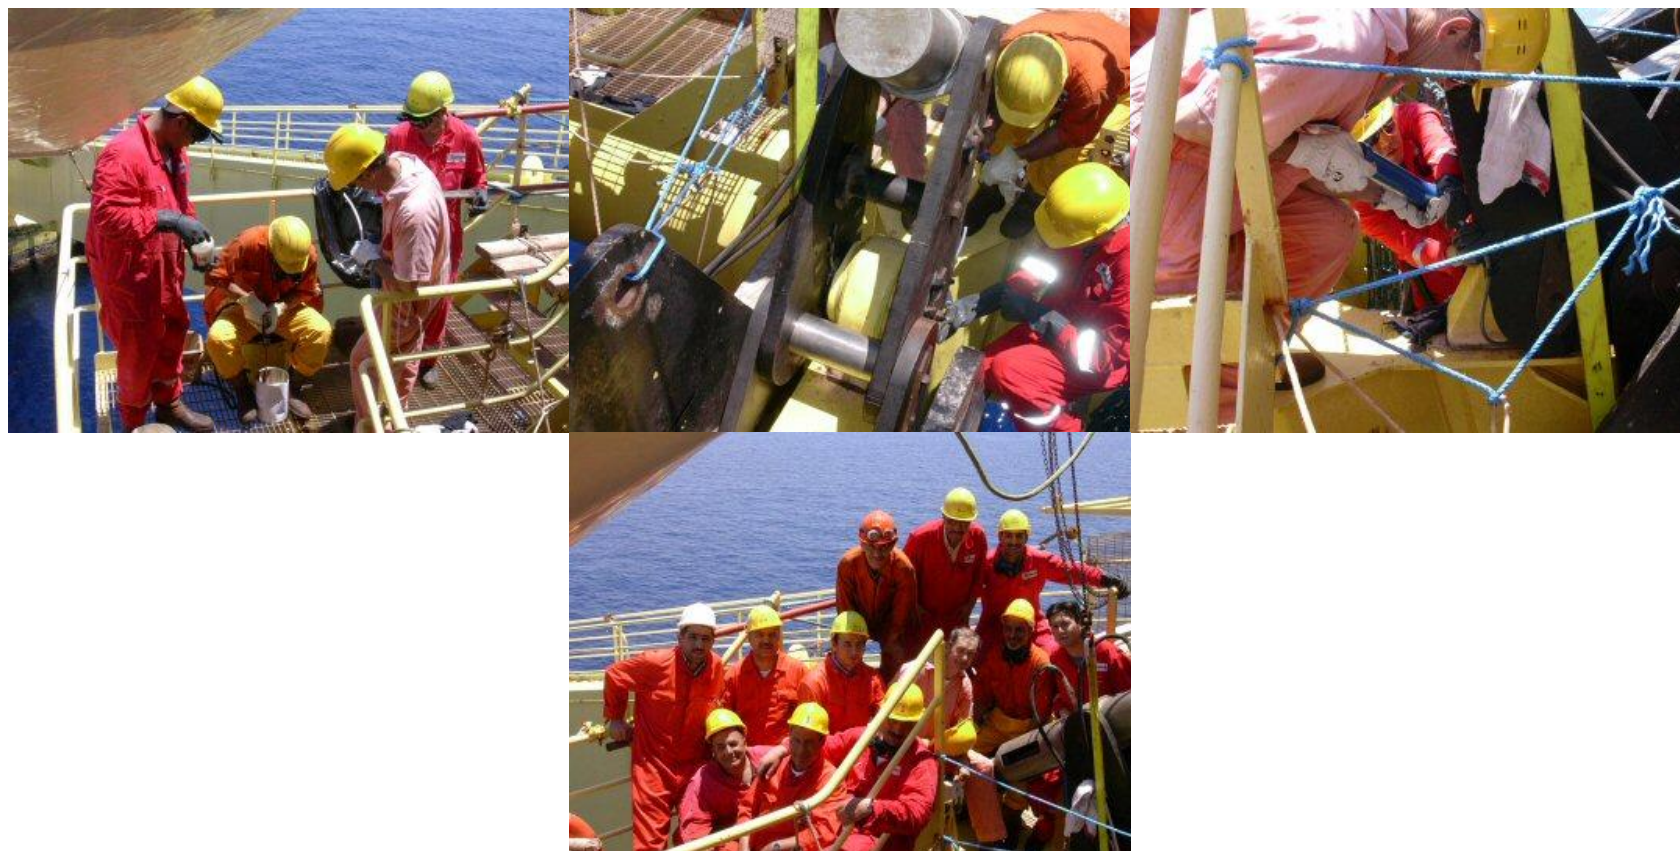
The special washers on the ends of the triangular plate pivot shaft were then sealed with neoprene and the tubing installed to be able to inject the resin.

The resin was injected until clean resin could be seen coming out of the upper vent pipes.

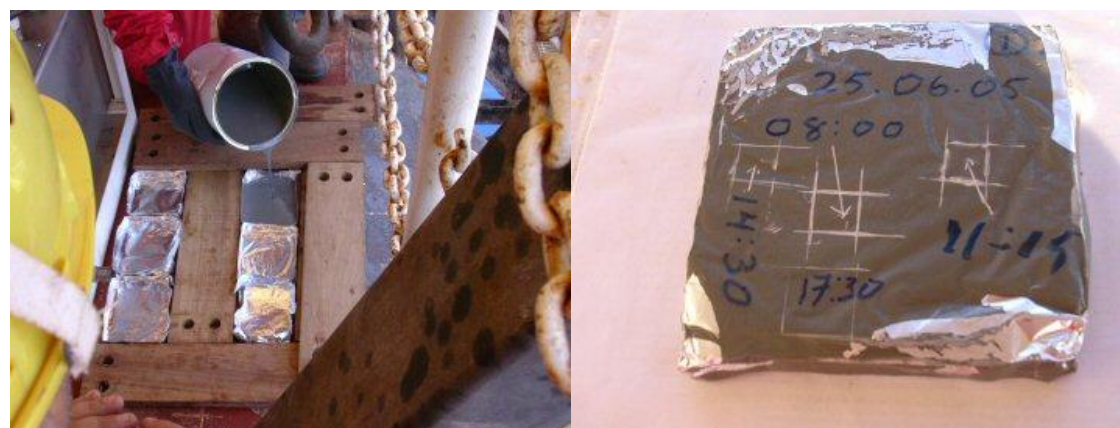
Test pieces were made. The test pieces (6 Samples) were tested periodically until such time that it could be assured that the resin was sufficiently cured to support the full load.

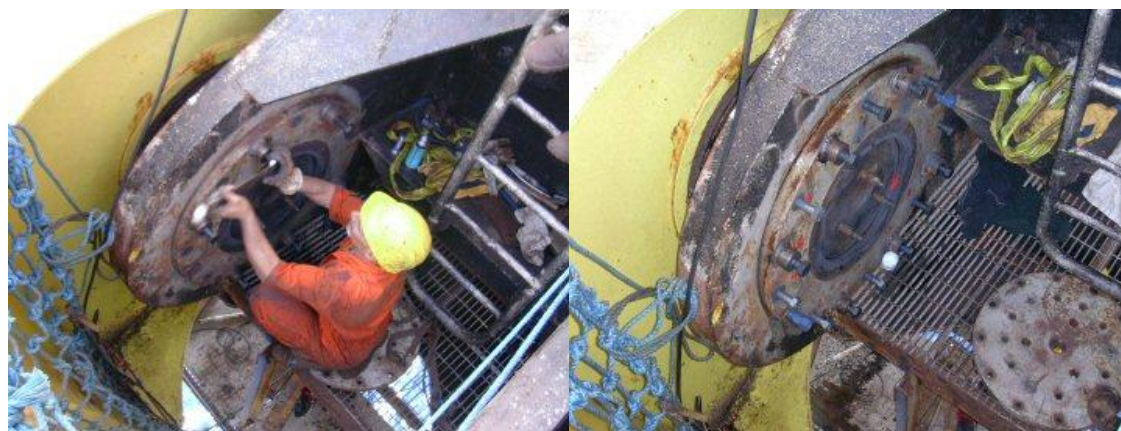
All holding bolts between the shaft cover plate and the ends of the shaft were removed, and the cover plates were removed (both inboard & outboard).

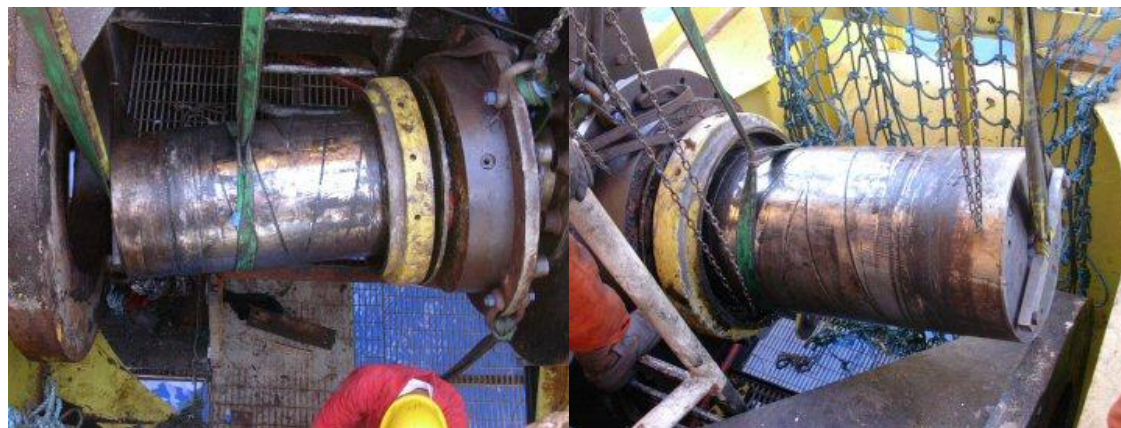
The shaft was examined to see which cone is free from the shaft, and which is still tight.

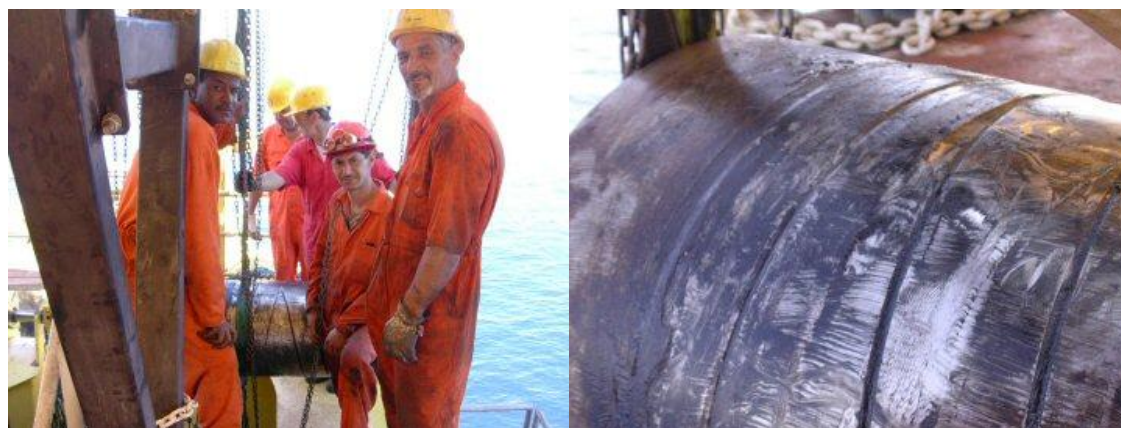
It was noted that the cones on both sides were moving freely on the shaft, so both cones were retracted equally simultaneously.
